SSC Service Bulletin

no. 84-342

MODELS AFFECTED: MCCU15RA, MCBU19A PA BOARD 504-165, REV. G AND FOLLOWING

PROBLEM: POWER AMPLIFIER IS NOT STABLE

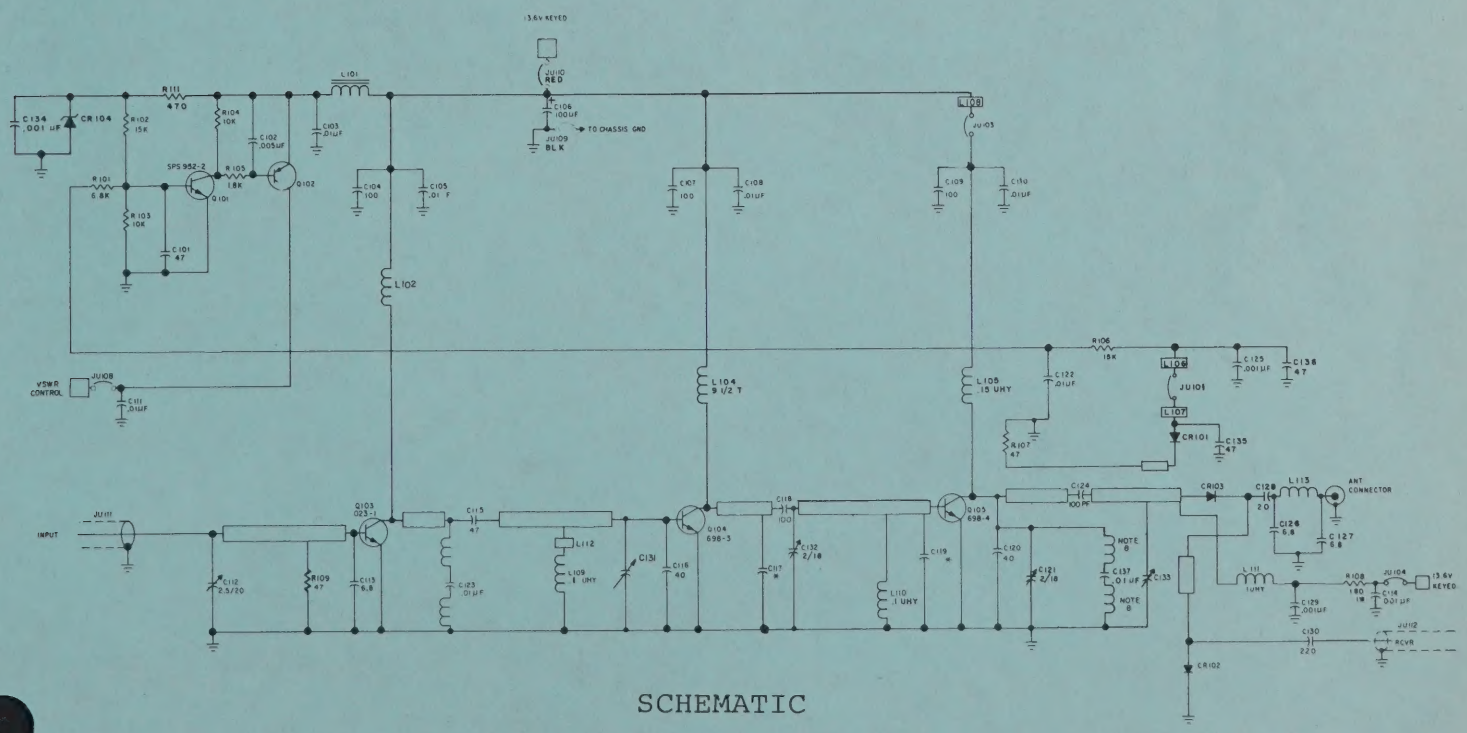
PROBLEM: POWER AMPLIFIER NOT STABLE

1. Change R109 from 100 ohms to 47 ohms, comp 10%, P/N 4700-0470-042.
2. Add C123, .01uF with 0.75" leads, Y5P, 100 VDC, P/N 1501-0103-031.
